Alta Vista Inspection Services

CONFIDENTIAL INSPECTION REPORT

12345 West Cactus Way, Phoenix, AZ. 85254

Inspection Narratives - Page 1

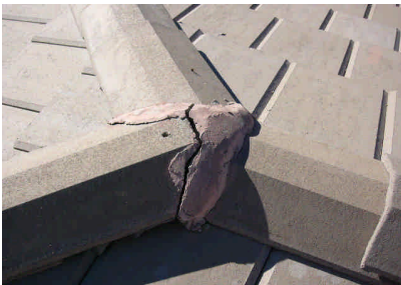
Issue: Gaps noted in the mortar on the roof

Explanation: Mortar should be installed at certain locations on the tile roof to make these areas water-resistant. If there are gaps in the mortar, the roof may leak in this area. (Repair Recommended)

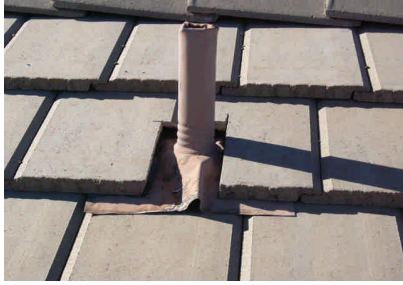
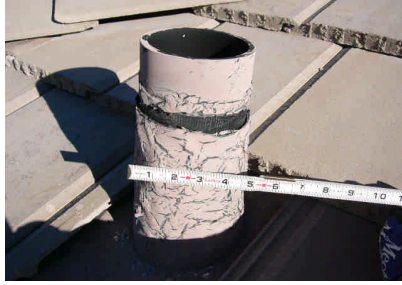
Issue: Gap(s) were noted at the roof flashing

Explanation: If there are large gaps at the flashings/penetrations the areas with gaps may leak. (Repair Recommended)

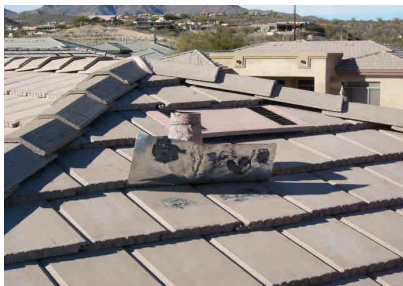
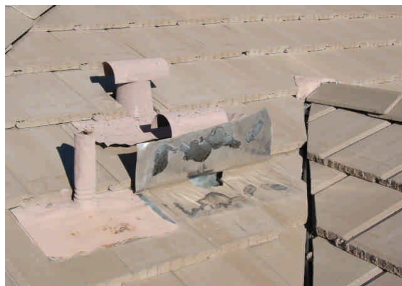
Issue: Loose flashing was noted at roof penetrations

Location: On the roof

Explanation: If roof flashing is loose, it may be lifted by the wind (usually during a rain storm) and may result in a gap or roof opening that moisture can enter. (Repair Recommended)

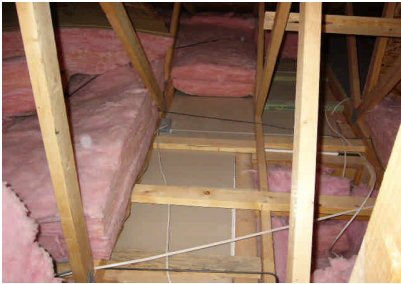
Issue: Missing insulation was noted on the ceiling (Some insulation has been displaced)

Explanation: Insulation should be installed between any heated/cooled area and any area that is not heated/cooled. Areas in the attic above spaces that are not heated/cooled, such as garages, patios and front porches, do not require insulation. (Repair Recommended)

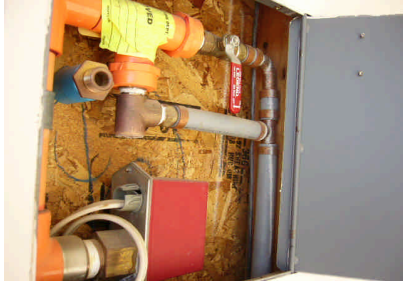
Issue: Polybutylene tubing noted at some portions of the fire protection piping

Explanation: In some installations, water piping utilizing plastic polybutylene may be more prone to leakage than other types of plumbing materials. If this is a concern for you, further evaluation is recommended before closing to determine if there is any other polybutylene plumbing in the house and if repairs are required. (Evaluation Recommended)

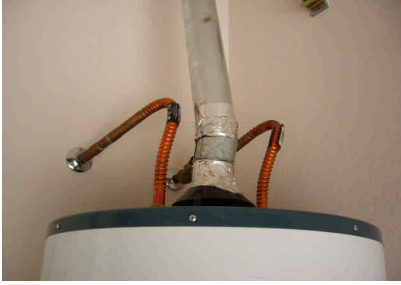
Location: At the water heater

Explanation: A gas flue that is not properly secured can become loose; resulting in the exhaust fumes entering the house. Most building standards require that three mechanical fasteners be used at each gas flue connection, (the fasteners should be evenly spaced around the flue) and where the gas flue connects to the water heater draft hood. (Safety Issue)

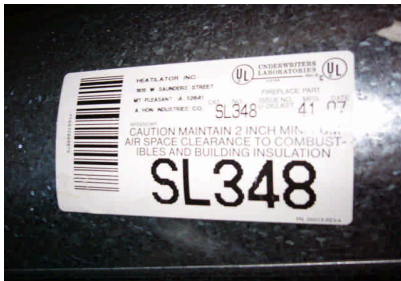
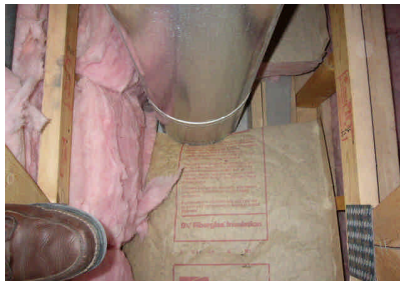
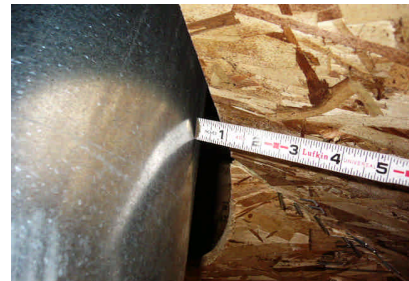
Issue: The fireplace flue or chimney was too close to combustibles (The left photo shows the label indicating that at least 2 inches of clearance should be maintained between the flue and combustible materials.)

Explanation: Fireplace flues must not be too close to combustible materials such as wood, insulation, wiring, etc. or a fire may result. Insufficient clearances should be corrected. (Safety Issue)

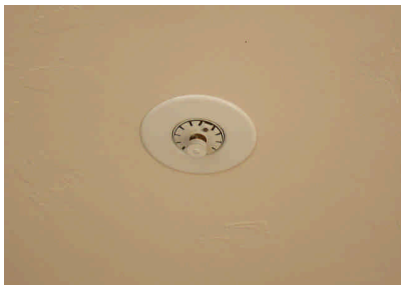
Location: Throughout the house

Explanation: Some Omega brand sprinkler heads, manufactured by Central Sprinkler Co., are subject to a safety recall by the U. S. Consumer Product Safety Commission. For more information, contact the Consumer Product Safety Commission at 800.638.2772 or www.cpsc.gov. (Evaluation Recommended)
