Alta Vista Inspection Services

EXECUTIVE SUMMARY

Client: John and Susan Doe
Realtor:
Inspection Address: 12345 West Cactus Way, Phoenix AZ 85254
Inspection Date: 12/07/2004 Start: 1:00 pm
Inspected by: Ron Peters, AZ Certified Home Inspector #38160

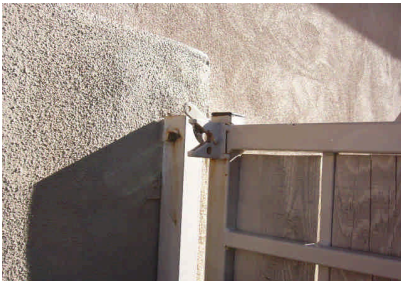
- 2.1 - Issue: Inoperable gate lock(s) were noted
Explanation: The pin for the gate latch is broken. (Repair Recommended)

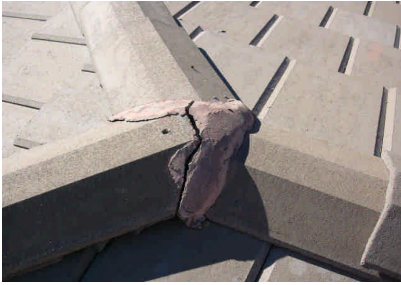
3.2 - Issue: Gaps noted in the mortar on the roof

Explanation: Mortar should be installed at certain locations on the tile roof to make these areas water-resistant. If there are gaps in the mortar, the roof may leak in this area. (Repair Recommended)

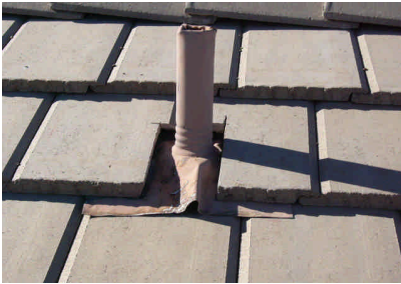
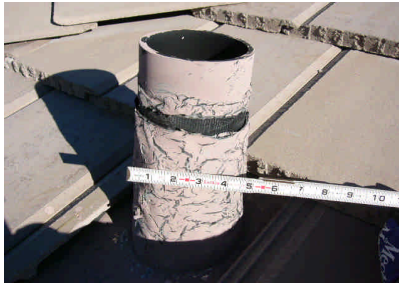
3.3 - Issue: Gap(s) were noted at the roof flashing

Explanation: If there are large gaps at the flashings/penetrations the areas with gaps may leak. (Repair Recommended)

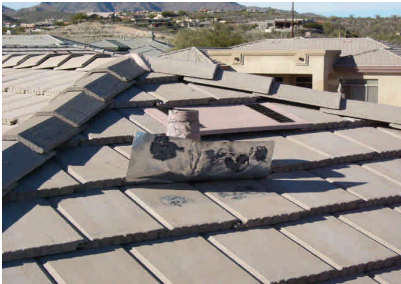
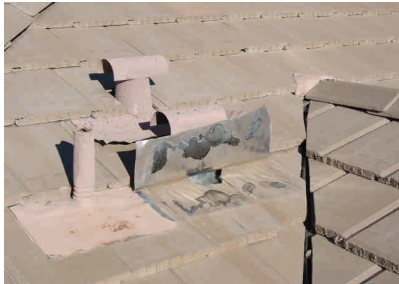
3.4 - Issue: Loose flashing was noted at roof penetrations

Location: On the roof

Explanation: If roof flashing is loose, it may be lifted by the wind (usually during a rain storm) and may result in a gap or roof opening that moisture can enter. (Repair Recommended)

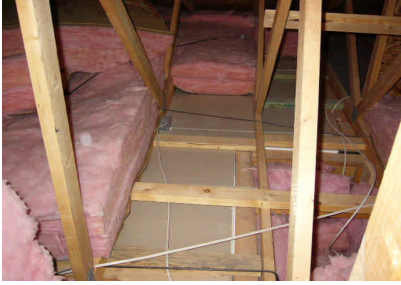
3.5 - Issue: Missing insulation was noted on the ceiling (Some insulation has been displaced)

Explanation: Insulation should be installed between any heated/cooled area and any area that is not heated/cooled. Areas in the attic above spaces that are not heated/cooled, such as garages, patios and front porches, do not require insulation. (Repair Recommended)

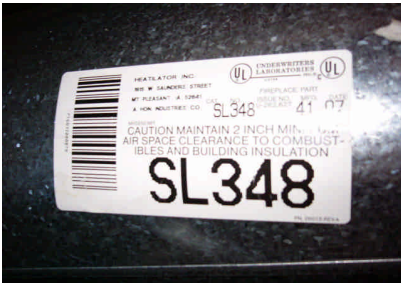
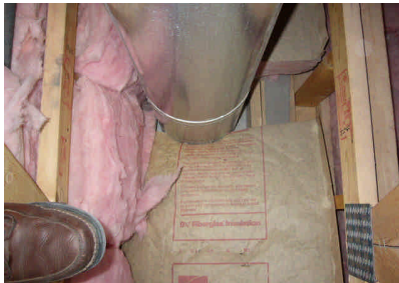
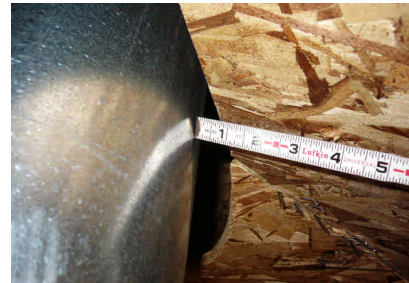
- 7.1 - Issue: The fireplace flue or chimney was too close to combustibles (The left photo shows the label indicating that at least 2 inches of clearance should be maintained between the flue and combustible materials.)
Explanation: Fireplace flues must not be too close to combustible materials such as wood, insulation, wiring, etc. or a fire may result. Insufficient clearances should be corrected. (Safety Issue)

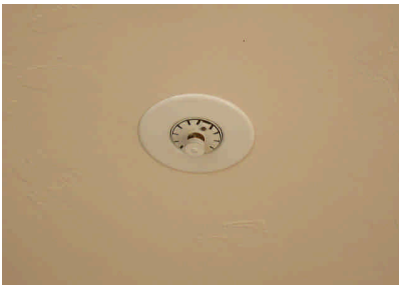
- 12.1 - Issue: The installation of Central or Omega type fire sprinklers is suspected
Location: Throughout the house
Explanation: Some Omega brand sprinkler heads, manufactured by Central Sprinkler Co., are subject to a safety recall by the U. S. Consumer Product Safety Commission. For more information, contact the Consumer Product Safety Commission at 800.638.2772 or www.cpsc.gov. (Evaluation Recommended)
